# Renovation not demolition: a case study of saving carbon on a private residence

This article describes a residential project to create a spacious, contemporary family home on the site of a 1960s building, following an early decision to renovate the existing structure, retaining as much of the fabric as possible.

Director, Giraffe Engineering,  
Chippenham, UK

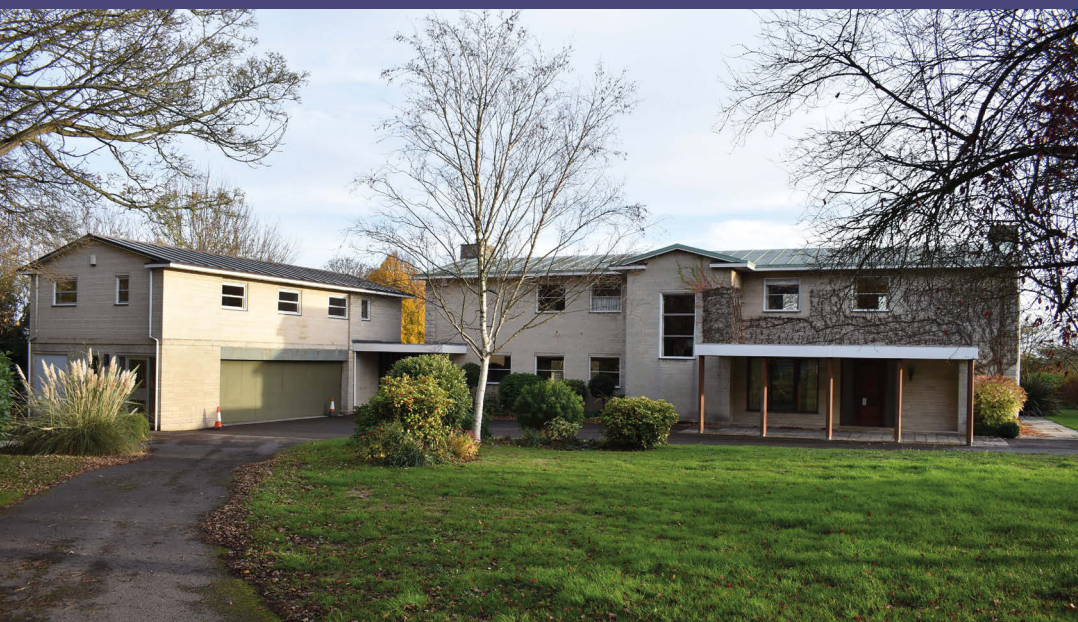
↑FIGURE 1: Existing house – front elevation

The original house (Figure 1) was well built and had some interesting features which would have undoubtedly appeared fashionable and futuristic in the 1960s, but now gave an overall impression of being dated.

It suffered from awkward proportions, with a low-pitched roof appearing out of proportion to the large masonry elevations and uncomfortably sized square window openings. The main cladding material of reconstituted stone with thick grey mortar joints had stronger connotations of concrete blockwork than the Georgian Bath stone it was trying to imitate.

The eaves were finished in white PVC panelling, drawing attention to the thickness and projection. A 'heavy' featured carport dominated the front elevation. A green copper-coloured membrane with fake seams to mimic a metal roof now appeared dated.

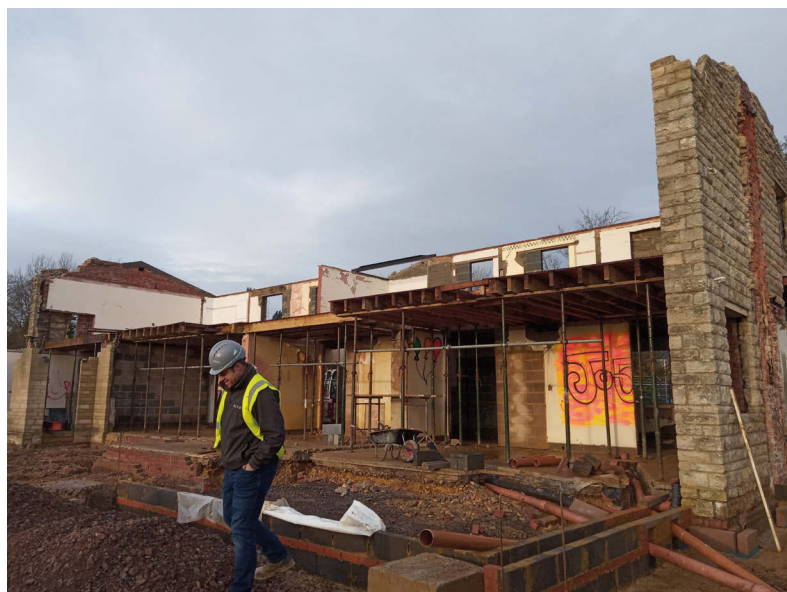
← **FIGURE 6:** What remained of existing house after demolition

We explored the possibility of retaining the first-floor masonry wall above the new openings, but this was found to be impractical due to the complexity of the required temporary works, especially since the entire roof structure was to be removed at the same time. Therefore, the entire rear elevation was removed, with propping installed to support the first-floor joists (Figure 6).

This presented the opportunity to rebuild the rear wall at first-floor level in timber frame rather than cavity masonry, which had the benefit of achieving a greater level of insulation and reducing the dead load on the supporting steel beams installed below.

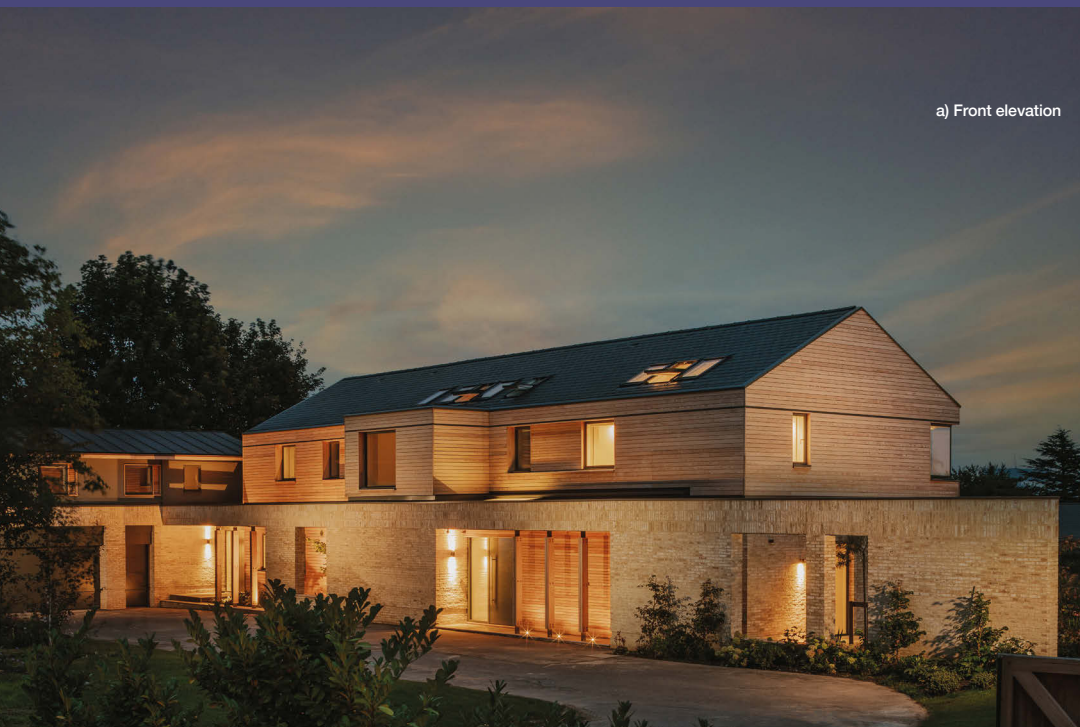
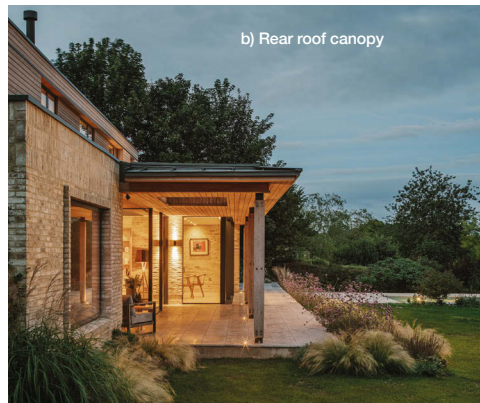
**FIGURE 7:**  
Completed building

a) Front elevation

b) Rear roof canopy

The creation of a projecting roof canopy across the rear elevation (**Figure 7**) was a key intervention to modernise the property and enhance the connection between the internal open-plan living spaces and the rear garden. This was formed by perimeter steel beams supported on a series of flitched timber posts with countersunk stainless-steel bolts. Thermal breaks were inserted into the steel connections where these penetrated the thermal envelope.

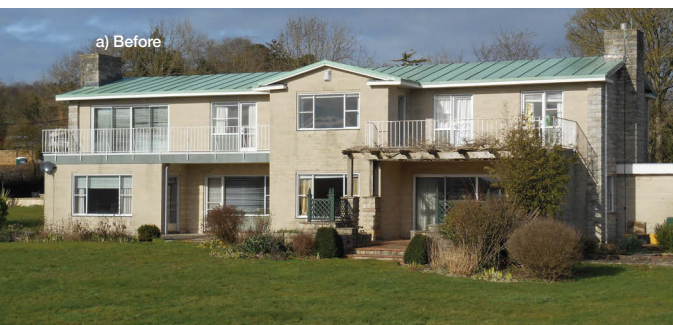
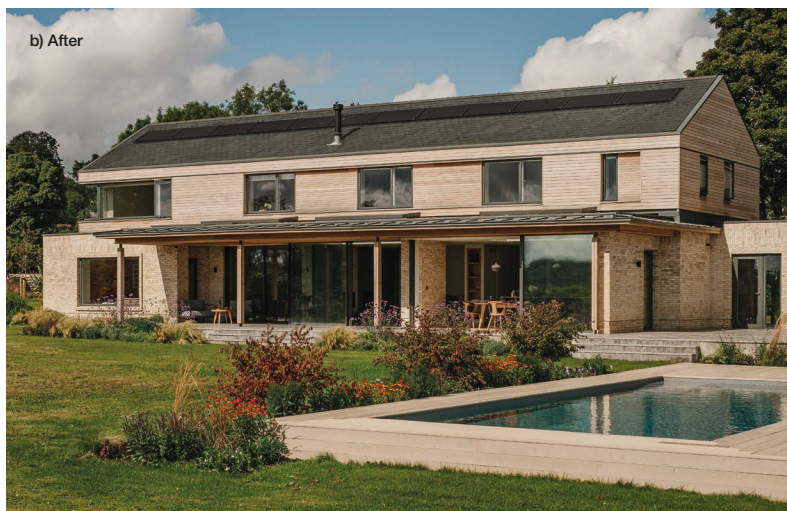
**FIGURE 13:** Rear elevation

Furthermore, this project has shown that working within the constraints of an existing building is not a barrier to achieving a high-quality architectural finish (**Figure 13**). The final result does not feel lessened or restricted by the original building from which it has emerged, but the project was instead strengthened by the challenge brought by the constraints it imposed on the design.

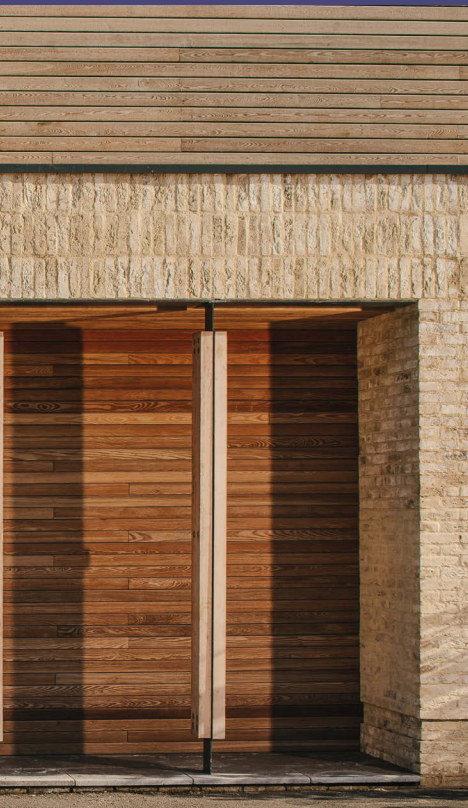
← **FIGURE 12:** Front entrance, showing contemporary palette of materials used

Structural embodied carbon is, of course, only one part of the overall picture. Non-structural components and architectural finishes on this project will include timber cladding (**Figure 12**), the slate roof covering, internal stud walls and plasterboard finishes, as well as floor coverings and insulation. These will all contribute to the overall embodied carbon of the project. However, all these
